Facility Asbestos Inspection

Facility: 509 East Market Street **Inspection Date:** 7-06-10
Location: New Albany, Indiana **Inspector:** Pete Welsh

Facility: 509 East Market Street – Single Family Dwelling

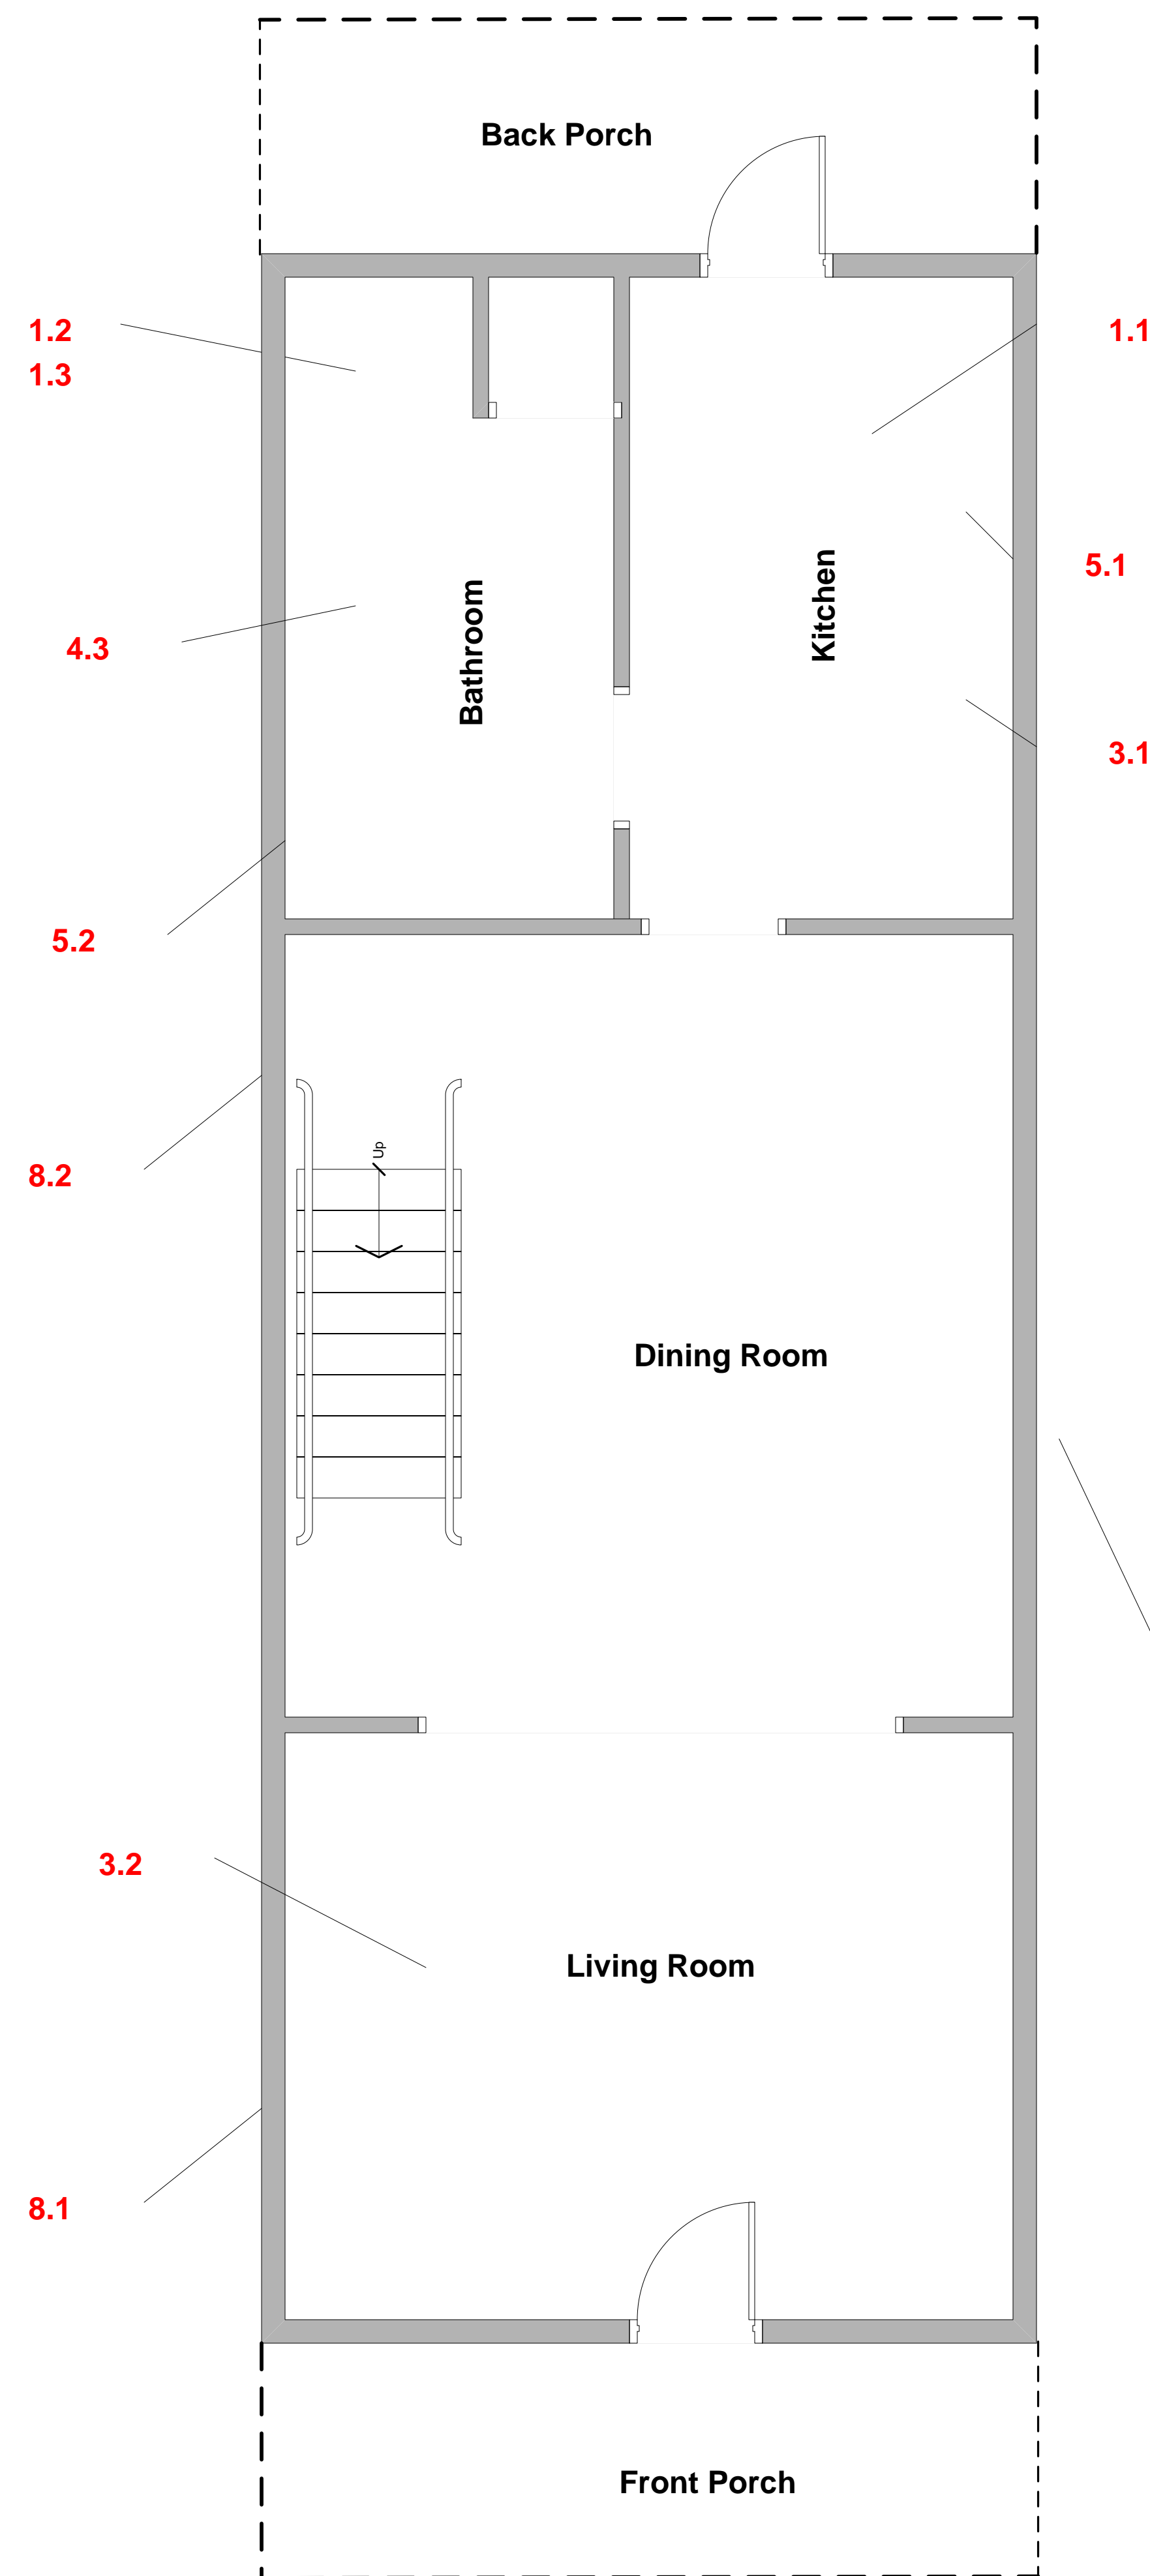
First Floor

1. There were no suspect ACMs in the HVAC system.
2. There were no suspect ACMs in the cellar/crawlspace.
3. There is Transite siding under the vinyl siding on the whole exterior of the house. This Transite siding contains 15-20% Chrysotile asbestos.
